# Hathmore Technologies, LLC

**Energy Audit for Gary & Bobbi Walker**

**March 18, 2008**

**Napoleon, MO 64074**

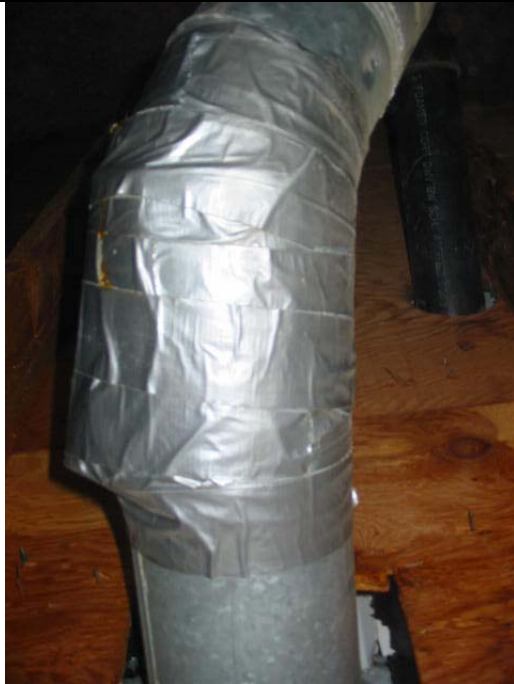
The flue pipe for the furnace and water heater has been sealed with duct tape. Duct tape will become brittle over time and lose its adhesiveness. This flue pipe should be repaired and continued out the roof with properly sized flue pipe. This should be a priority fix as flue gasses can infiltrate the home through gaps and cracks in the ceiling and can cause illness.

- 1. Repair flue in attic**
- 2. Remove extra layer of drywall in attic**
- 3. Seal attic penetrations and basement-to-attic bypasses (including, attic access and whole-house attic fan)**
- 4. Seal and insulate rim joist**
- 5. Install additional insulation in attic**
- 6. Perform remaining work as detailed above**

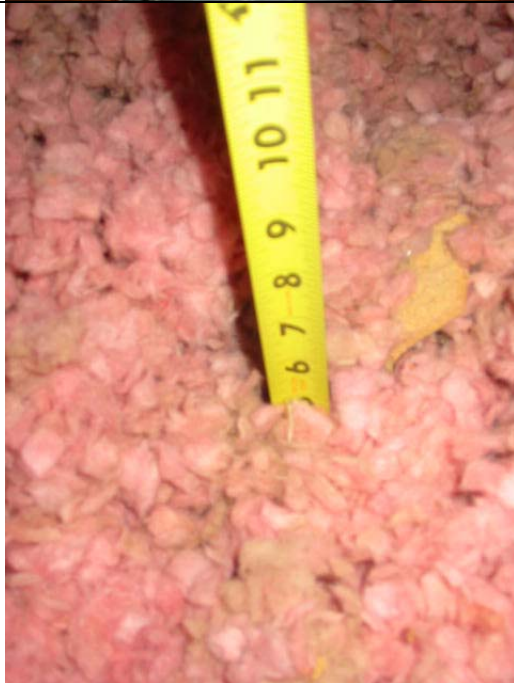
Attic insulation is a 5" layer of fiberglass batt topped with drywall and 5-9" of blown fiberglass with an R-value of 27. An insulation value of R-49 is the recommended value for our region.

The sheet rock between the layers of insulation acts as an air barrier and could trap moist air against the thin layer of batt insulation below. The sheetrock should be removed.

Fiberglass insulation performs best when sealed on all six sides. In an attic, it tends to allow air to pass through and infiltrate through cracks and gaps in the ceiling. Recommendation is to rake remaining insulation smooth and blow a minimum of 6" of cellulose over the fiberglass. Cellulose will provide a better air seal and is not attractive to rodents.

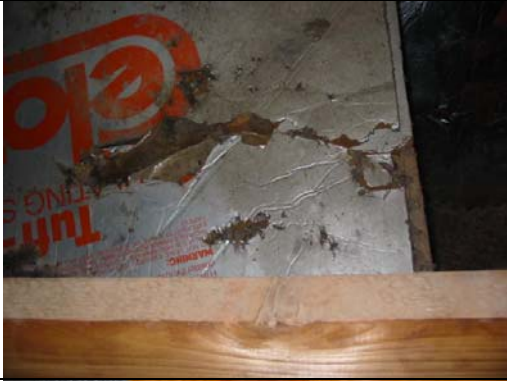
<p>The ceiling above the stairway and the knee walls have fiberglass batts covered on the attic side by foil faced foam board insulation. This makes a good air barrier, however, some of the facing has been torn and the seams are not taped. Recommendation is to repair all tears and seal all seams with foil tape.</p>

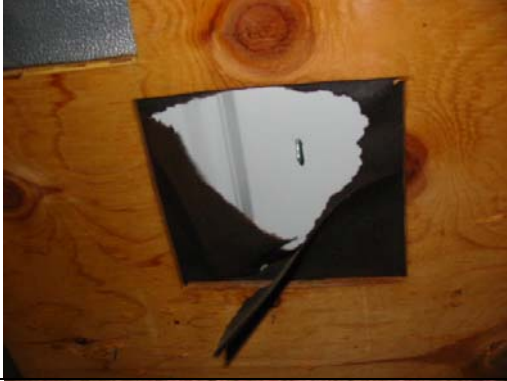
<p>New ventilation was added with the new roof, however the old vent holes were not covered. The tar paper that was put over the holes has become damaged. This means that if any water gets behind the roofing it has a large, open direct path into the attic. This tar paper needs to be repaired so that any water that gets behind the roofing will be directed to the lower roof edge, and it would be a good idea to seal the old vent holes with plywood to prevent future damage to the tar paper.</p>

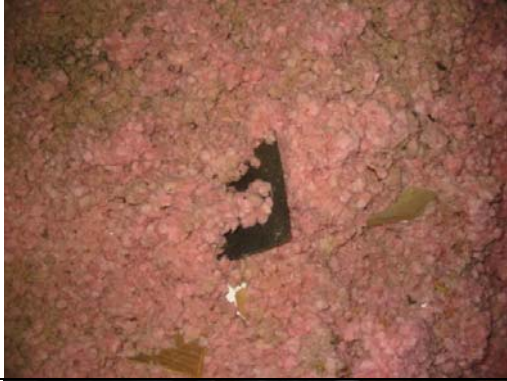
<p>There is debris in the insulation. This inhibits the homes energy performance as well as encourages mold, mildew and insect and rodent infestation. Debris should be removed prior to adding additional insulation.</p>

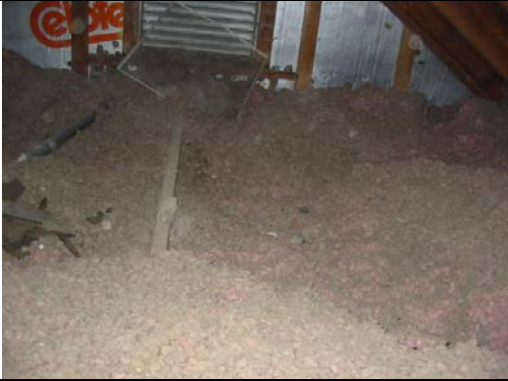
<p>The insulation in the upper attic is being blown around by the whole house attic fan. There are drifts of insulation and areas with very little insulation. This usually happens when there is not enough free ventilation area for the size of the attic fan. The air cannot get out of the attic fast enough, so it causes a lot of turbulence and blows the insulation away from the ceiling.</p>

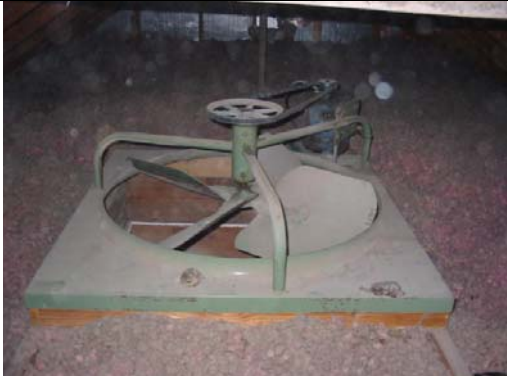
<p>Whole house attic fans are very leaky. If this unit is not going to be used it should be removed and the ceiling should be sealed and insulated. If it is going to be used, it should be insulated and additional ventilation area should be added to the attic. Information regarding attic fan insulation kits can be found at: <a href="http://www.highenergybills.com">www.highenergybills.com</a></p>

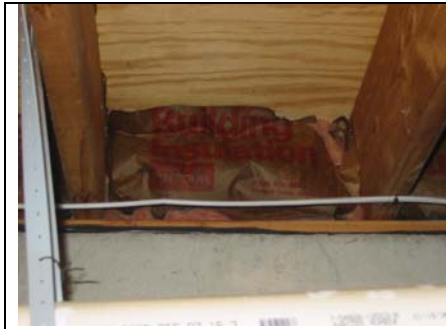
The rim joist is insulated with fiberglass batts but not well sealed. If improvement to this area is desired, recommendation is to remove all fiberglass insulation and seal the rim joist with expanding foam insulation. This will provide a complete air seal as well as insulate.

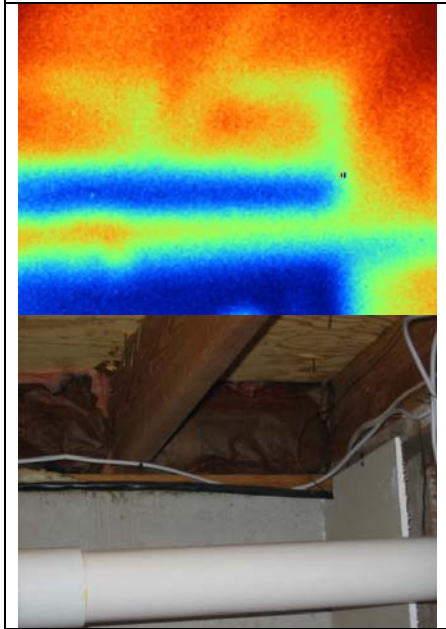
This photo shows air leaking in between the rim joist and the foundation.

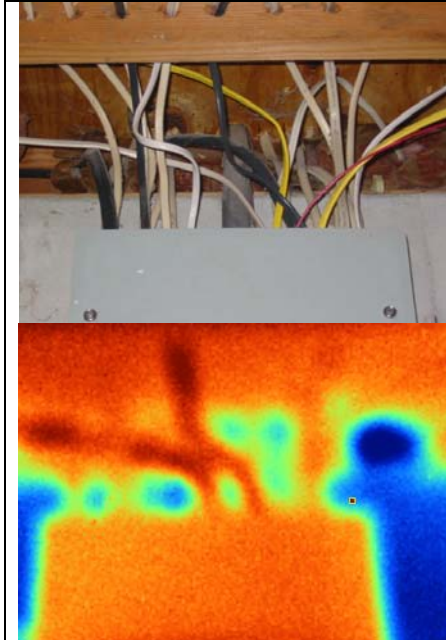
The electrical penetrations into the rim joist should be sealed with foam.

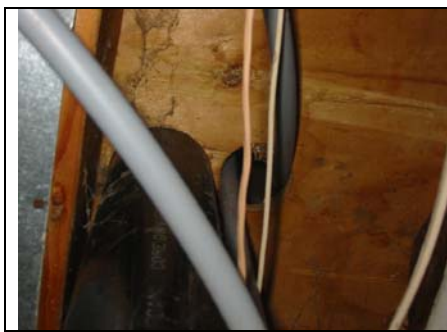
<p>There are several basement-to-attic bypasses where wiring or plumbing stacks penetrate the basement ceiling and go up through to the attic. These openings should be sealed at both the basement and the attic with foam or caulk.</p>

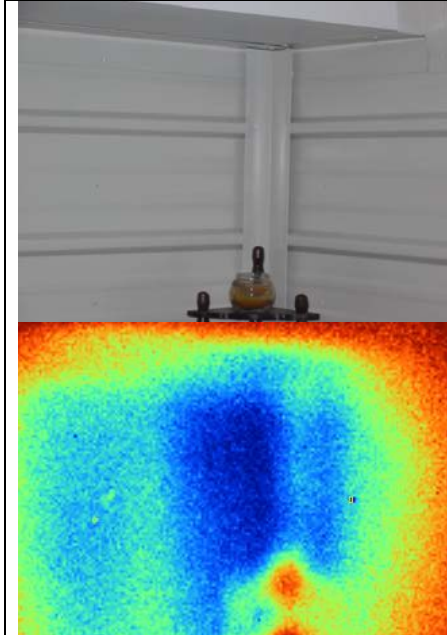
<p>The infrared photos show that there is probably no insulation behind the steel panels in the basement. If you decide to insulate the basement walls, we recommend a foam product such as spray foam or foam board. Fiberglass insulation installed in direct contact with concrete can promote mold growth.</p>

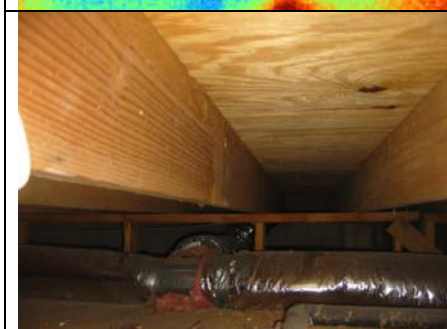
<p>The floor of the master bedroom is not insulated. This area is above a very short crawlspace above a slab. It is highly likely that the band areas around the edge of this floor are also uninsulated. Recommendation is to blow this area full of cellulose insulation taking care not to shift or dislodge any of the ductwork that runs under this floor.</p>

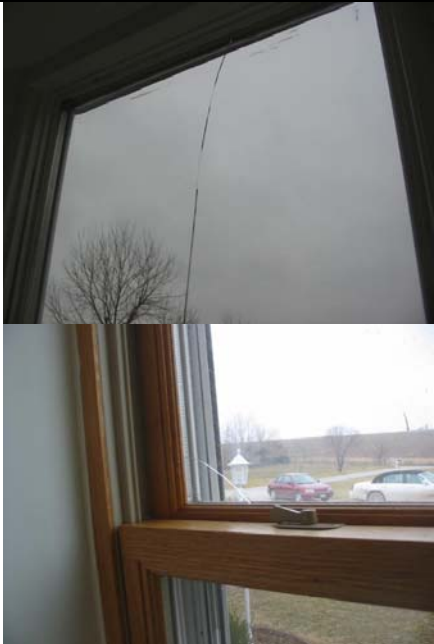
<p><b>Windows are double pane with wood frames and for the most part are performing well. There were two windows with cracked glass that should be replaced.</b></p>

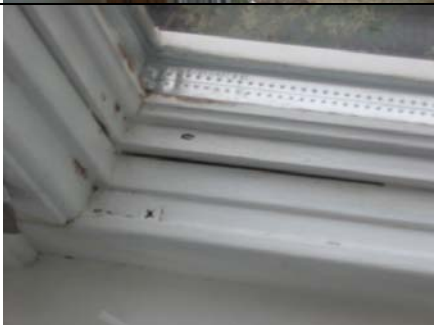
<p><b>Some of the windows, especially the casements in the bay window in the Master bedroom have been painted shut.</b></p>

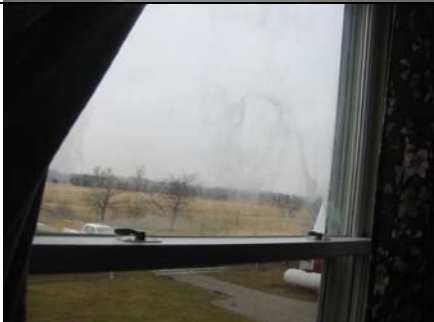
<p><b>There are signs of condensation between the glass panes of the sash of one of the windows in the pink bedroom. This means that the seal between the panes of glass has been broken which reduces the insulating value of the window. The entire window can be replaced (costly) or the glass and seal can be repaired (less expensive).</b></p>

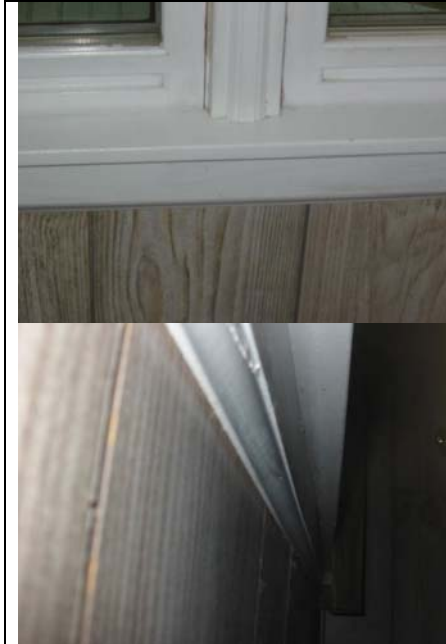
**The windows in the entry are leaking around the trim. Recommendation is to remove the trim and air seal and insulate with minimally expansive foam product approved for windows and doors or seal around the trim with a paintable caulk.**

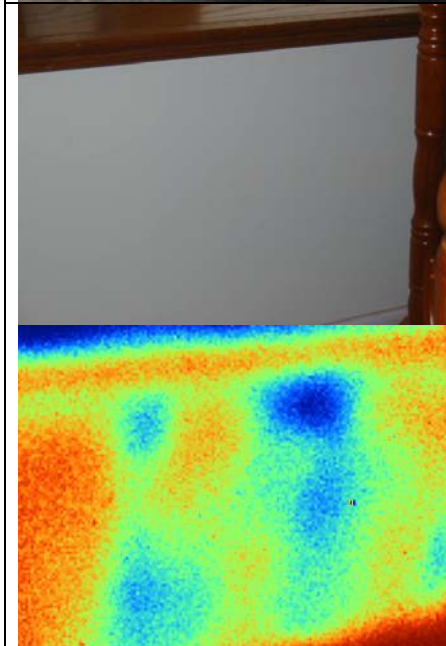
**The cantilever under the dining room window showed some leakage. The exterior should be sealed (as discussed above) and packed with cellulose insulation to reduce air flow and increase the insulation value.**

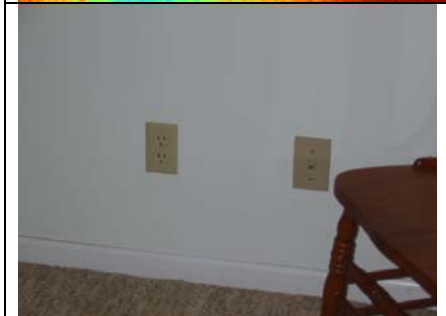
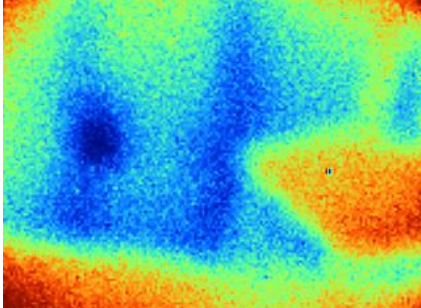
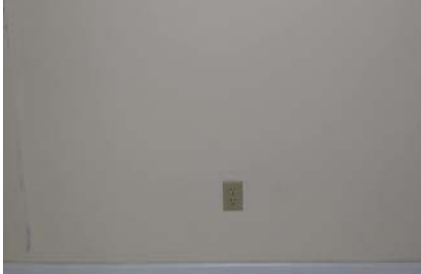
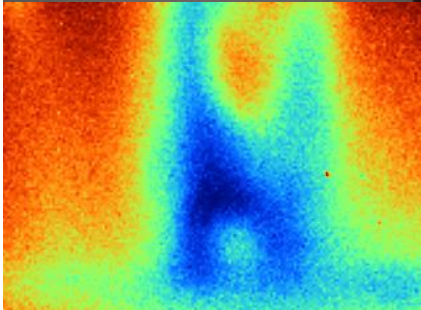
**Outlets were leaking some air. The infrared photos show air leakage through some outlets, coming up from the rim joist.**

<p><b>Same as above.</b></p>

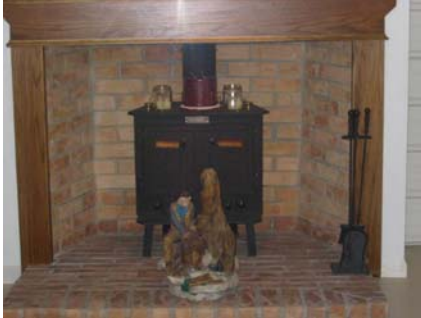
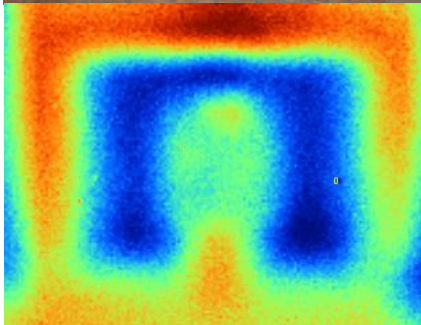
<p><b>The wood stoves in the home do not seem to be leaking outside air into through the flue. As you can see, the brick around the woodstove in the basement is transferring heat to the foundation wall behind.</b></p>

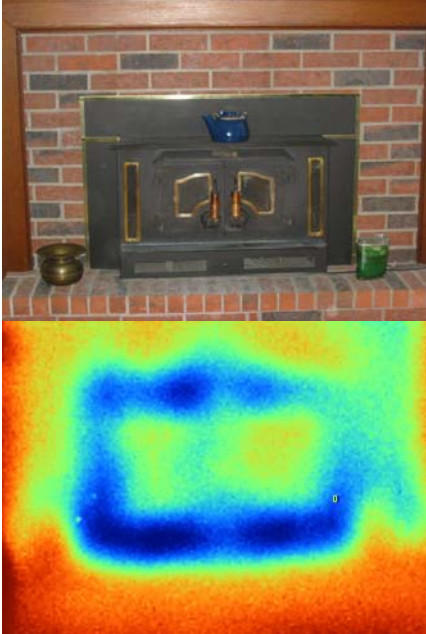
<p><b>There is some air leakage or heat loss through the frame around the wood burning stove on the main level.</b></p>

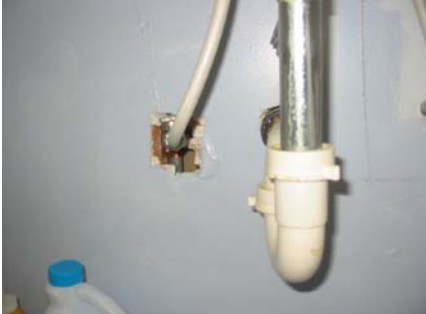
<p><b>Plumbing penetration at the upstairs bathroom sink was leaking some of air and should be sealed.</b></p>

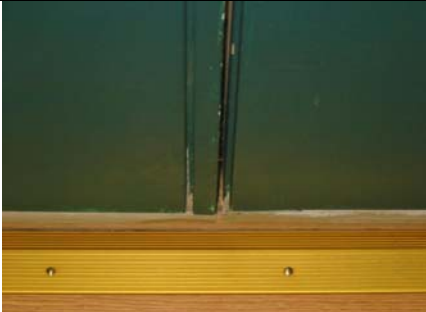
<p><b>Daylight could be seen between the double doors to the deck. New weather strip should be installed.</b></p>

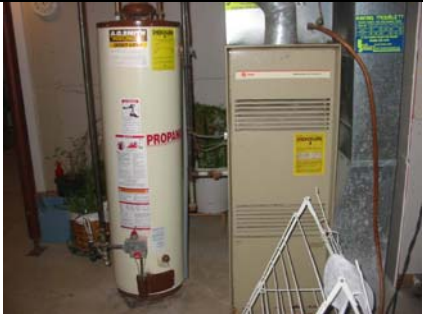
<p>Furnace is a Trane, Model #BLU108F9368 with listed AFUE (Annual Fuel Utilization Efficiency) of 71% and an input of 108,000 BTUs. The unit is showing signs of age including rust. This furnace is a good candidate for replacement.</p>
	<p>Most installed heating and air-conditioning systems (even new systems) run at 50-60% capacity due to ductwork leakage and other system inefficiencies. If the unit is not going to be replaced, recommendation is to have the system professionally tested and 'tuned' and include annual maintenance procedures for both the furnace and the air conditioner. HVAC companies that perform this testing are listed below.</p>

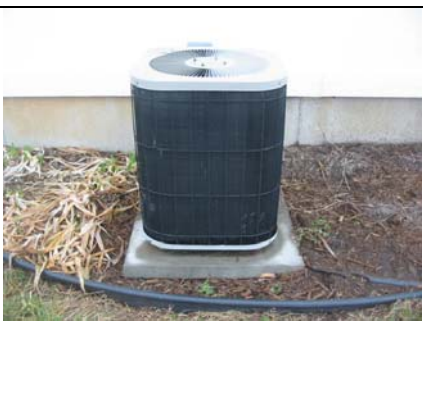
<p>The air conditioner is a Goodman, Model #CK36-1A with a seasonal Energy Efficiency Ratio of 9 SEER and a cooling capacity of 33,000 BTUs.</p>
	<p>In January 2006, the minimum allowed by law became 13 SEER.</p>
	<p>The coil fins are clean, which helps maintain the unit's efficiency, however, it was installed at the same time as the furnace and is showing signs of wear. The A/C unit should be replaced as well.</p>

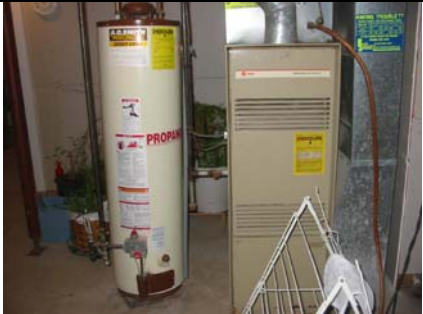
<p>Water heater is an AO Smith, Model #FSG 30 233. It has an Energy Factor of approximately .60, meaning that it is basically 60% efficient and \$0.40 of each dollar spent to heat the water is wasted heat. The tank and water lines could be insulated to help boost the overall system efficiency. You may benefit by installing a tankless water heater to reduce energy usage and costs. Tankless water heaters heat water as it is needed to practically eliminate standby losses.</p>

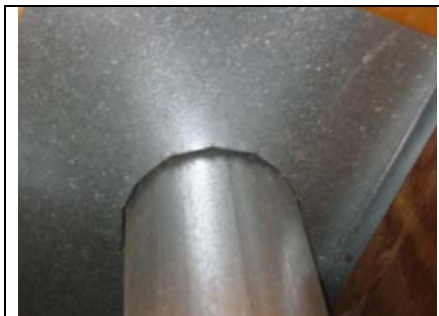
<p><b>This gap around the flue pipe should be sealed with fire-rated caulk.</b></p>
 	<p><b>The gaps around the duct risers should be foamed.</b></p>
 	<p><b>This infrared shows how the open chase from the basement to the attic is pulling cold air into the conditioned space and cooling the ductwork and piping. Once these chases are sealed at the attic and basement the ducts and piping will be at interior temperatures and will not lose heat to the outside.</b></p>
 	<p><b>These water and sewage lines penetrate the return cavity. The water lines or the return should be rerouted or, at minimum, the holes should be sealed with mastic or foil tape.</b></p>

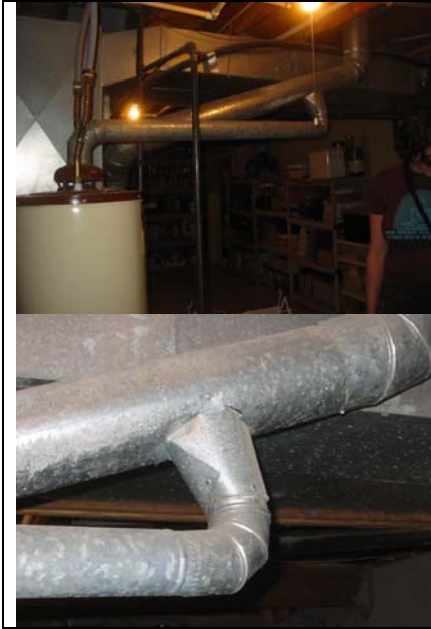
**The flue for the water heater has a long horizontal run, sharp bends and enters the main flue line at a 90 degree angle. This combination can lead to backdrafting and spillage of carbon monoxide into the home. The water heater should be tested for carbon monoxide levels, spillage and draft, especially whether the water heater is able to establish draft if the furnace is already running and the water heater is cold. The “T” connection should be changed to be an angled “Y” entry to the combustion line in order to help ensure the exhaust gasses can enter the draft created by the furnace.**

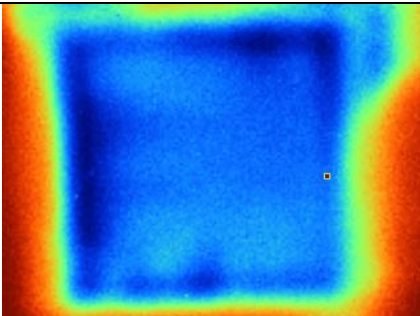
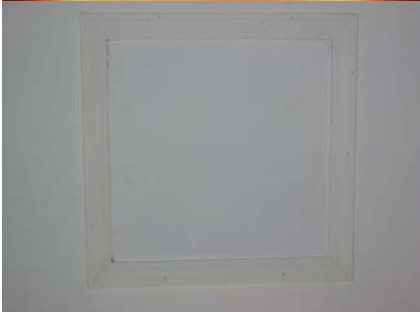
<p><b>Air leakage and heat loss through the attic access in the Master Bedroom closet.</b></p>

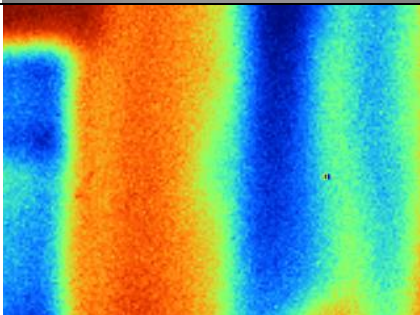
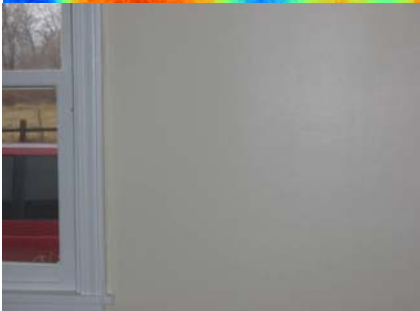
<p><b>This photo shows a wall cavity with missing insulation next to a window in the master bedroom.</b></p>

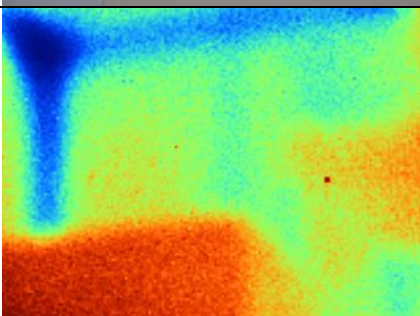
<p><b>This photos shows some air leakage at the band joist and outside corner.</b></p>

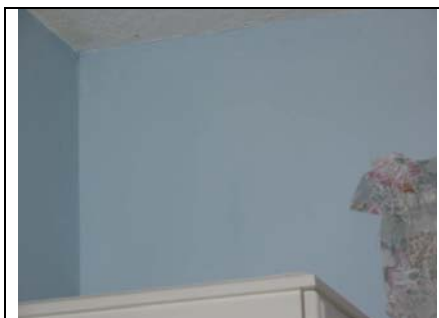
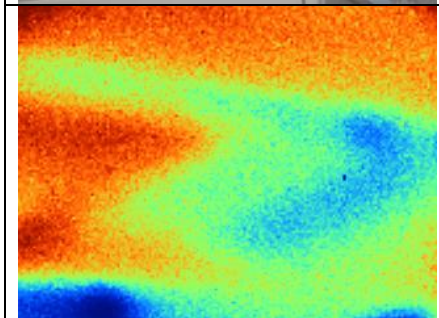
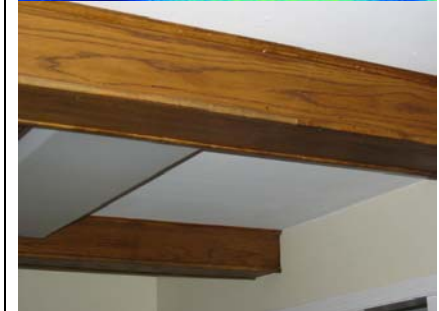
<p><b>This shows an area over the kitchen ceiling that is cold. The band joist area between the first and second floors is likely not insulated, or there is another exterior penetration near this area that should be sealed.</b></p>

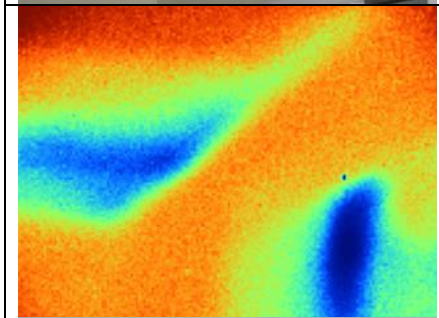
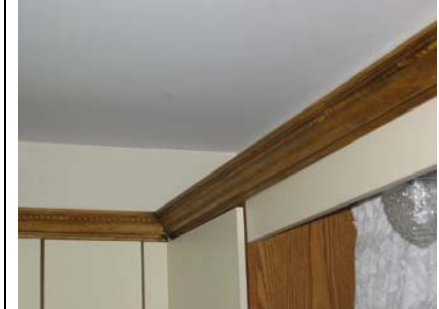
<p><b>This corner over the kitchen cabinets is also cold. This again points to an uninsulated band joist area.</b></p>
