# PLAYHAVEN FARM LLC & GREEN BUILDING PROJECT

## GREENOVATION : INSULATION

### REPLACE FIBERGLASS IN ATTIC WITH CELLULOSE (MAY 2010)

### **ADD CLOSED-CELL FOAM TO CRAWLSPACE BELOW MASTER BEDROOM/BATH AND BASEMENT RIM JOIST (SEPTEMBER 2011)**

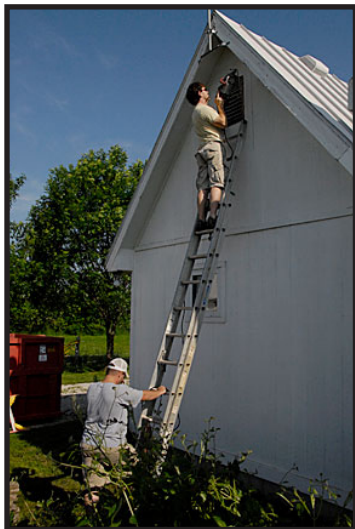
The gable vent on the south side over the master bathroom was a likely candidate especially since we had been thinking it needed to be a bigger vent for the amount of attic space it vented anyway.

So, first things first, Eric removed the 14x22 vent (which turned out to be installed behind the siding... another pain in our side) and cut an opening big enough for the new 24x36 vent. I had to purchase that size vent on-line because none of the home improvement stores carry such big vents.

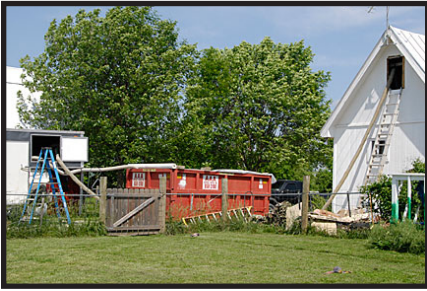
Here is the set-up...

On the left is Eric's trailer with the machinery and hose and cellulose, etc. (it's a really big trailer - you only see the front 1/4 of it in the picture).

In the middle is the 20 cubic yard dumpster from our trash company (close up below in case you want their phone number) with the scrim cover weighted down so that the loose fiberglass stays in the dumpster when it comes out of the hose. They usually use water to wet-down the fiberglass, but we only had 20 psi at the field hydrant and so this was their other option.

On the right you can see the opening with the hose coming out and part of the pile of drywall removed at that point.

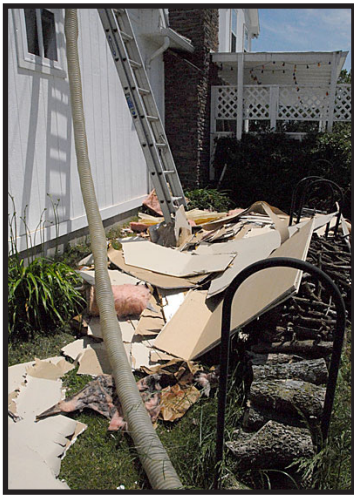
Here is a close up of the pile of material being removed from the 1st floor attic area. Note the fiberglass paper at the bottom of the picture with the mold. Scary to think that could have been a lot worse.

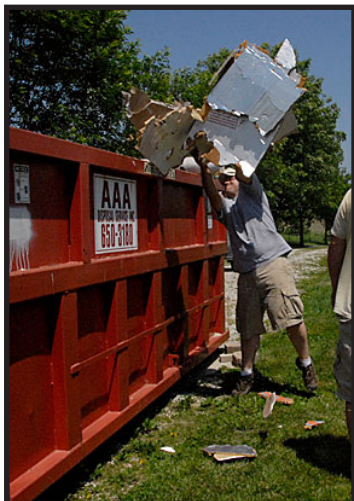
And, no, the drywall was not reusable, nor is there any program in the area to recycle it. If it weren't for all the nails, we had considered putting it on our driveway to supplement the gravel, but alas, that too was not an option. So into the dumpster the drywall went.

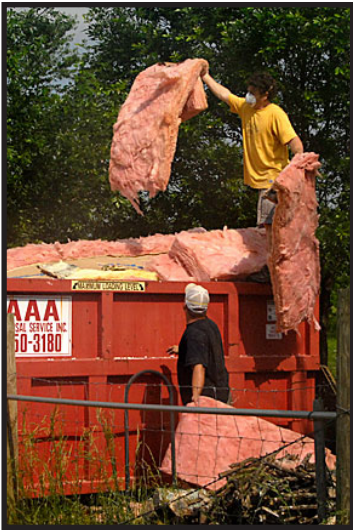
Eric had hoped that the bat insulation would be in good enough shape for him to reuse and that was our understanding from the beginning. Which is the reason we only got a 20 cubic yard dumpster.

Unfortunately, it was not in good enough shape to reuse and so we both agreed it should also go in the dumpster.

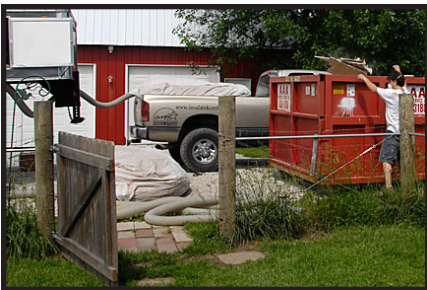
Having so much bat fiberglass go in to the dumpster meant there wasn't enough room for everything after all... so Eric filled 3 big bags (you can see 2 in the picture at left) with the 2nd floor loose fiberglass. He was able to put one in the dumpster and took the other two back to his shop and his own dumpster.

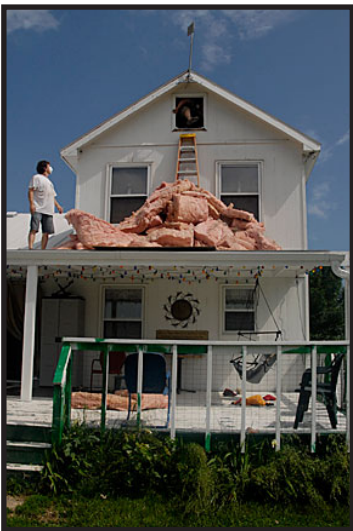
Eric discovered that the vent to the 2nd floor attic was also installed behind the siding. So, we ordered another vent (24x30, same size that was already there) and he cut out the old one.

Thank goodness the roofers beefed up the structure of the ceiling over the porch when they fixed the roof. It made it much easier to get the fiberglass and drywall, etc. out of that attic.

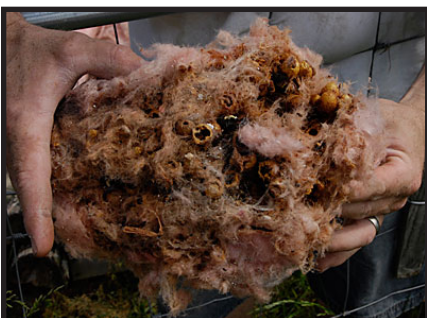
Here is a rather interesting thing they found in the 2nd story attic. It's a bumble-bee nest in the loose fiberglass. Eric said its all very sticky. And you can just see a bumble-bee near the center of the picture between a patch of pink fiberglass (to the right) and a kind of yellow/orange tube opening (to the left)... its a very dark spot with a bit of a yellow line on top of the spot.

The roofer had told us the screen on that vent has bad... they had a heck of a time with wasps and bees.

Knowing this, Gary put up a bunch of sticky paper scrolls to help reduce the numbers before the insulation was to be brought out.

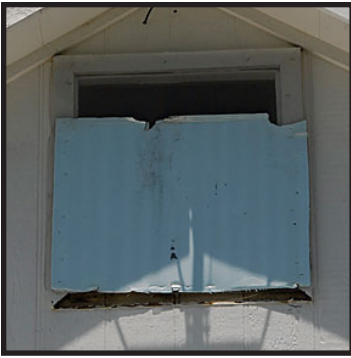
Since we had to order another vent, Eric devised a temporary solution to keep out the 'wildlife' and the rain until he can come back out and install the new vent -- once it arrives.

You can't really see it, but there is metal screen material behind the foam board.

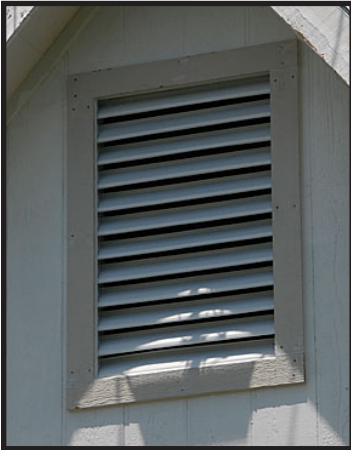
Here is the 24x36 gable vent installed and ready to be painted.

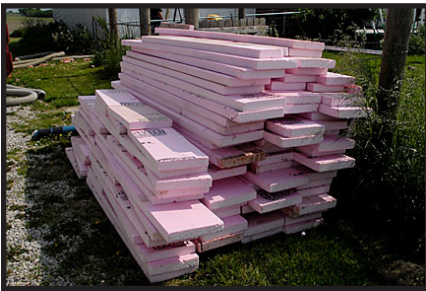
Ah yes, forgot to mention that they found the pink foam board shown at left in the attic... it wasn't sealed in or anything - just laying in the ceiling area over what used to be the porch and is now the entry hall. The insulating properties are not effective if its not sealed.

We are going to be using it in the loft area of the garage... one of our do-it-yourself over time projects.

And, Eric, being the great guy he is, used a couple pieces to insulate the hatch cover in the master bedroom closet (sealed and everything).

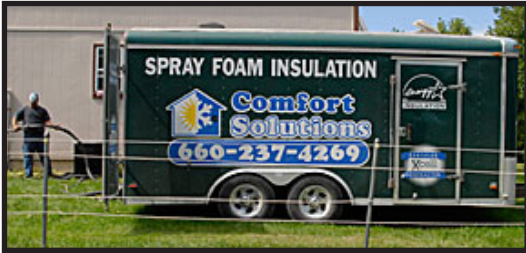
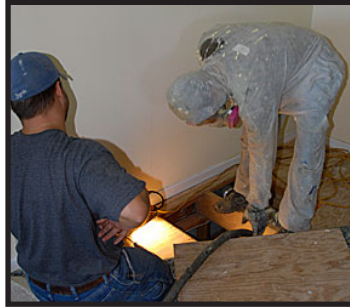
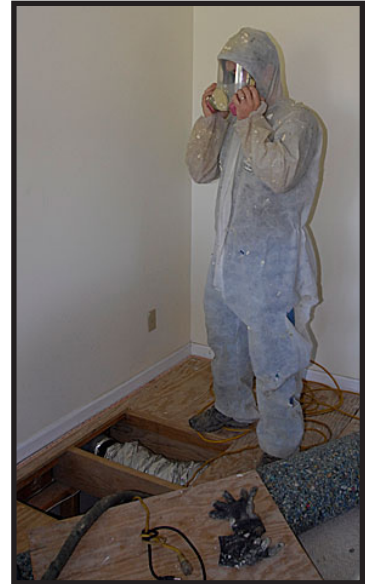
This is all BioBased 1701s® Spray Polyurethane Insulation (1.7 lb. closed cell). Eric wore a mask, gloves, etc. because the two components separately are bad to breath and get on your skin. When they mix together (at the sprayer) and cure, they are inert. This product is GREENGUARD Certified for Children and Schools, Class 1 Fire Rated.

The photos were taken after the foam had cured. Thanks to the hubby for being willing to go back down into that crawlspace for me.

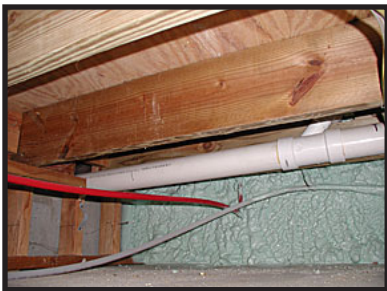
The wall at left is the basement wall (east),so it did not need to be sprayed.

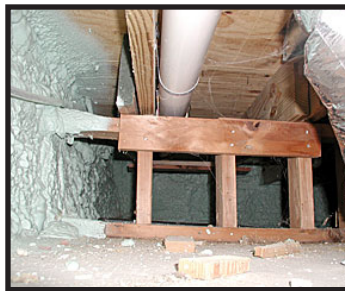
South wall (at left) and west wall.

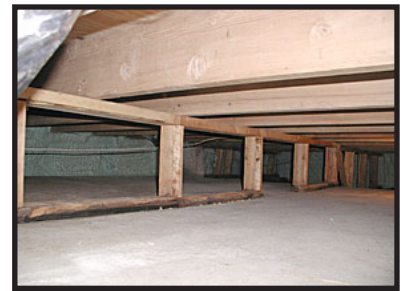
West wall.

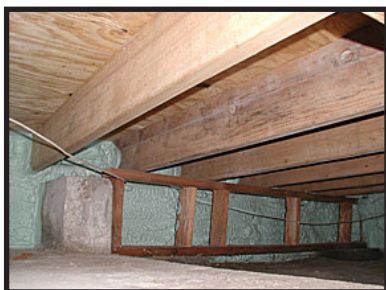
Close up of west wall where the concrete floor of the garage ended and the foundation was extended to the north.

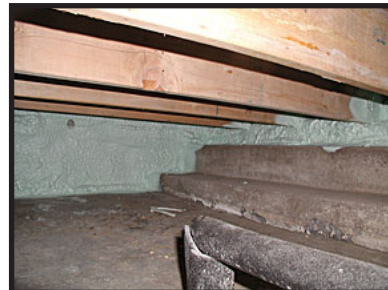
Northwest corner where the stairs from the driveway went up to the porch.

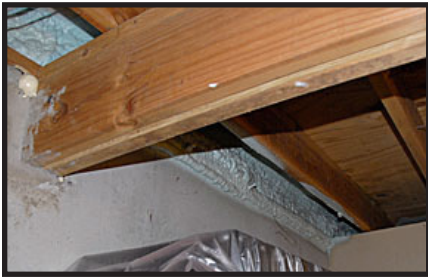
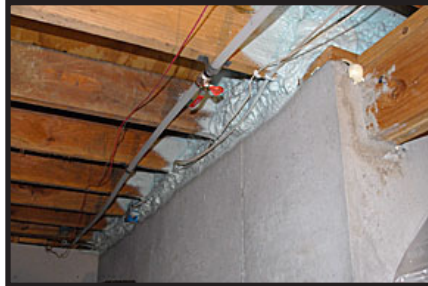
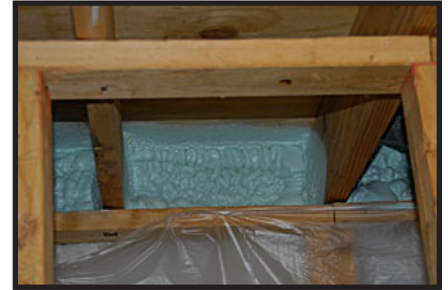
The photo above left shows the closed cell foam along the rim joist and the one above middle shows it is also between the floor joists.

I forgot to mention that in the basement, the guys also removed and disposed of the old fiberglass bat that 'insulated' the rim joist.

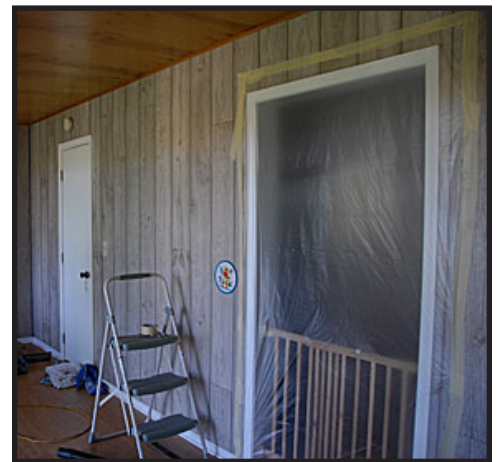
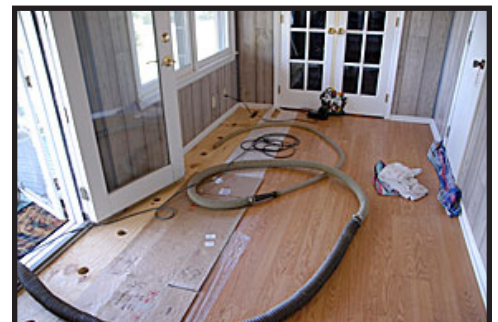
This required a bit of prep work on our part. There is a laminate wood floor in that area and the hubby removed the baseboard and enough of the flooring so that Eric could drill a hole in the subflooring into each cavity (between floor joists which run north and south, the width of the area). I put painters plastic over the doorway to the living room (taped all the way around, removed the furniture, wall hangings, curtains, etc. and stuffed towels at the bottom of each french door with tape in the gap where they meet to keep the cellulose dust out of the rest of the house.

After the guys (of Comfort Solutions) did the closed cell foam applications, they came back a couple days later and put cellulose (high borax content) in the gap between the current floor and the old concrete porch floor of the north hallway. We are sure that this area is where we had mice coming in last year and that is why we decided to go with the high borax cellulose... even if they start to burrow in, they won't live long enough to make it through. Sad for them, but necessary for us.

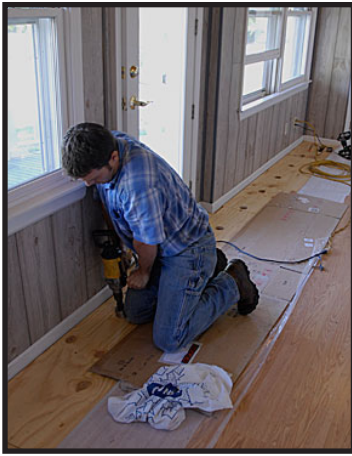
Drilling the holes.

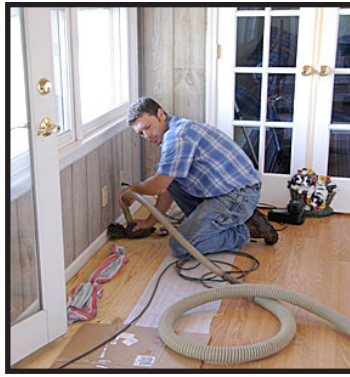
Notice how he stuffed a towel into the next couple of holes in case there were any openings between the cavities.

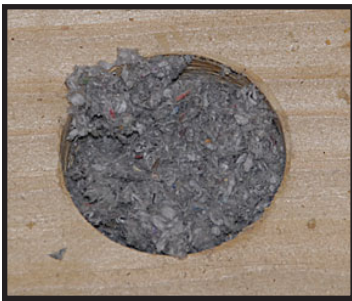
This is what the cellulose looks like.

Each cavity is densely packed.

It was interesting to see watch Eric determine how it was filling up... there was a difference in sound, the material slowed in the tube until he pulled it out enough to allow more room to fill up. I was fascinated.
