PLAYHAVEN FARM LLC & GREEN BUILDING PROJECT

GREENOVATION : SIDING

INSTALL CEMENTATIOUS FIBER SIDING (APRIL 2011)

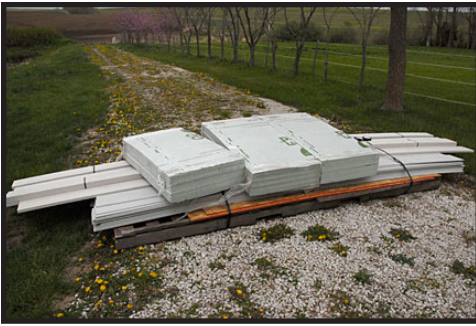
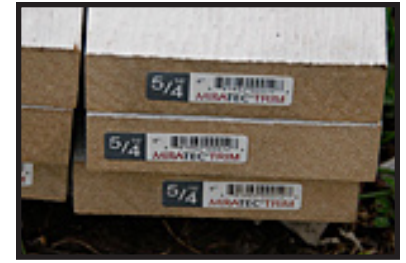
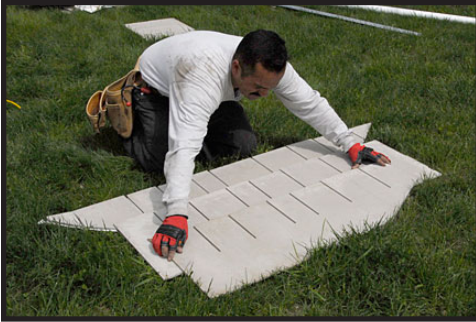
Above from the Left: Hardie board Shingle Siding with Green Guard Wrap Insulation; Certainteed Lap Siding; Green Guard Wrap Insulation (close up); and Miratec Trim Boards.

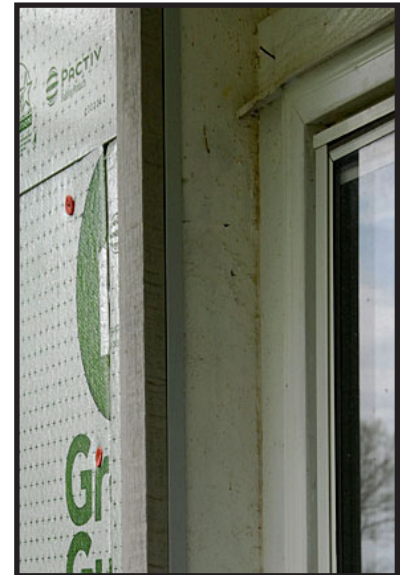
I was SO happy to see that the guys put flashing under this trim board! This had been a horribly rotted board due to it's location at a valley of the roof.

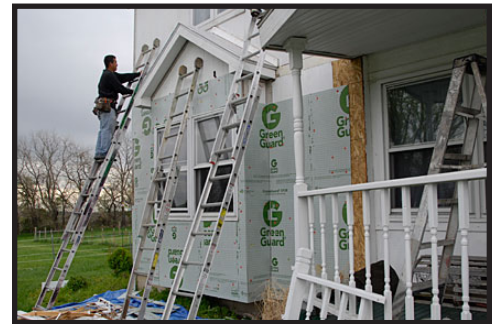
Here you can see part of the new OSB that hasn't already been covered by the Green Guard Wrap Insulation.

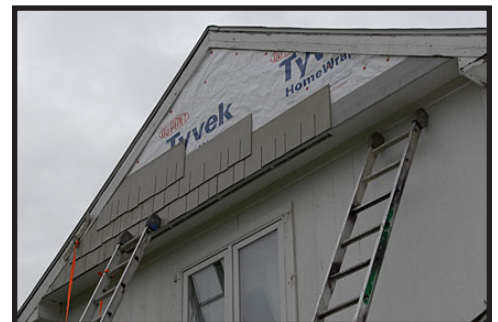
While the Green Guard was used over the conditioned living space, it wasn't needed in the attics, so they put Tyvek wrap there to minimize moisture.

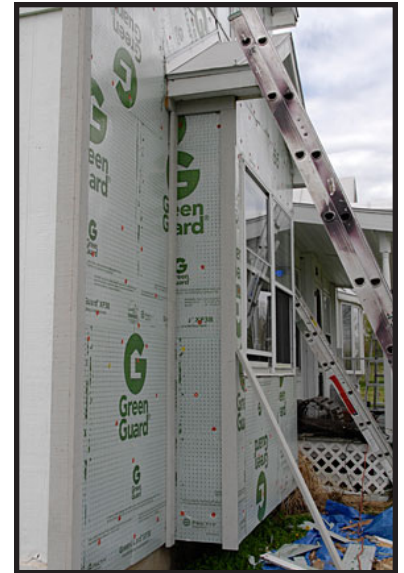
The process interests me. I did not even think about what goes up first... the lap or the trim. Here you can see that they put the trim in place first and then butted the lap up against it.

The closer the fit, the less caulk and the less chance of leaking.

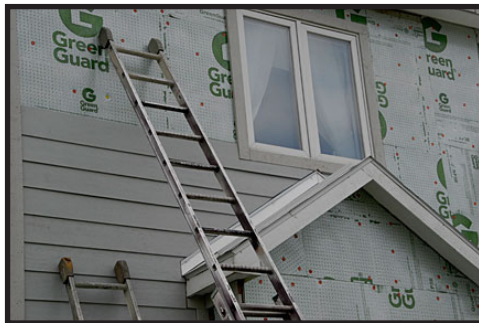
This picture is to show how very precise Carlos and David work was. Look closely at the peak of the bump out roof and notice that there is a tiny notch in the trim board of the window.

Plus everything that should be flashed, IS flashed!

The caulking will be done by the paint crew.

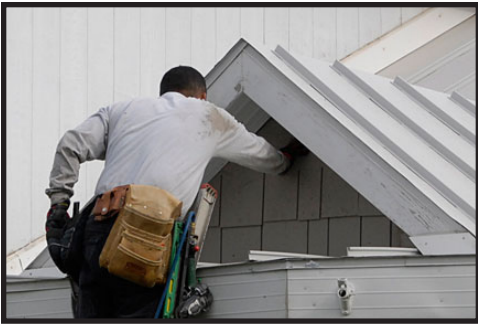
Fitting the shingles in the tiny decorative gable on the porch.

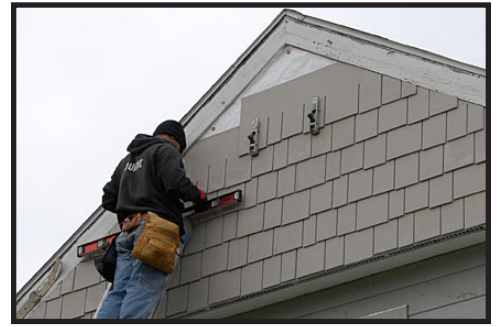
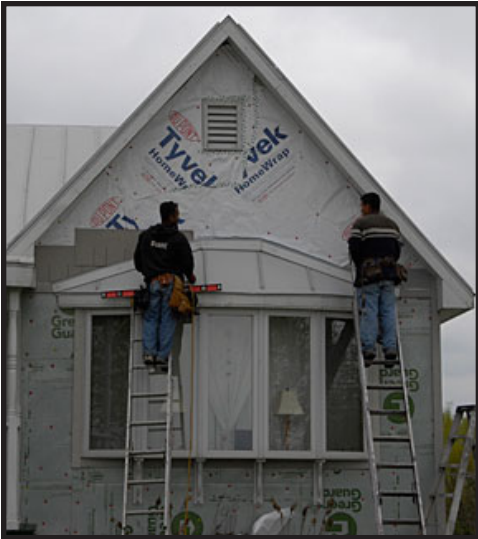
David using the level and a glimpse at the tools that hold the board in place.

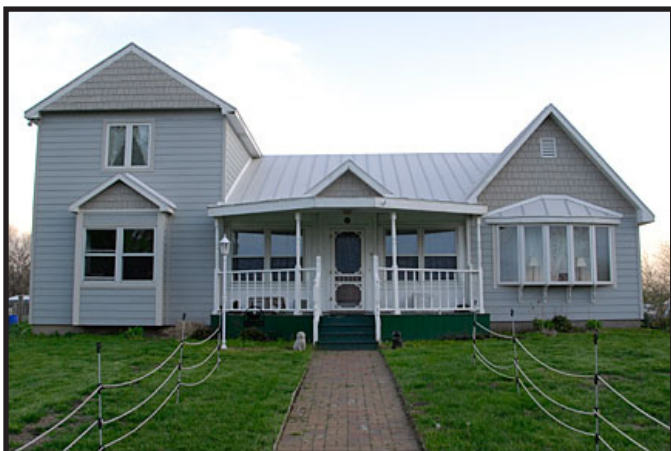
Siding repaired and new installed!
